DC Isolator Failures Resulting in Fire

In the first six months of 2014 four voluntary recalls for solar DC isolator switches were registered with the Australian Competition and Consumer Commission (ACCC). A further DC isolator was voluntarily recalled in 2012. All of the five rotary style DC isolators that were recalled experiencing the same defect; localised heating, due to higher than desirable contact resistance occurring on one of the contact points. That is, the failure mode was excessive heating at a contact when operation at normal current level.

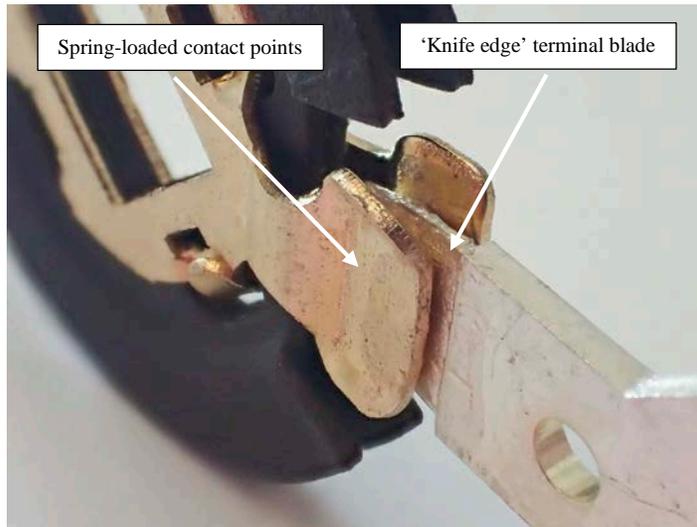
Photo 1: DC Isolator Contact Point

The rotary style contact point design shown in *Photo 1* is a very common design for the DC isolators used in the solar industry, including many that haven't been recalled by the ACCC. *Photo 1* shows one of the two contact points for one pole of a typical DC rotary isolator. As the rotary handle of the DC isolator is turned, the 'knife edge' terminal blade makes connection with the spring-loaded contact points.

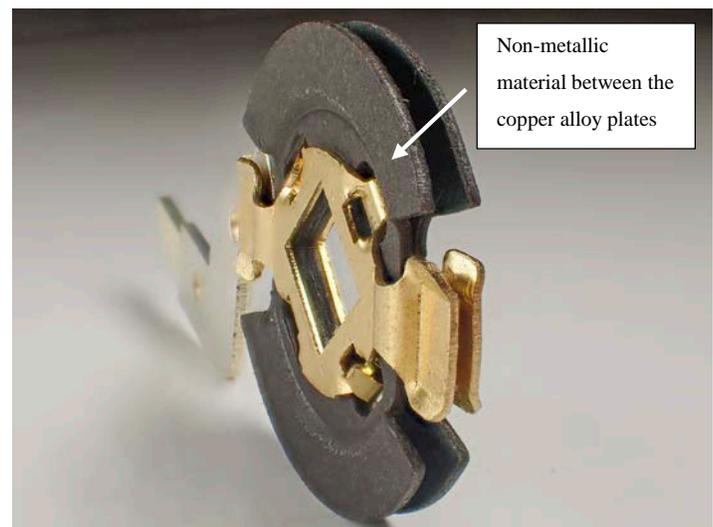
Photo 2: DC Isolator spring-loaded contact points

The fast switching action allows for the constant DC load to make / break contact with minimal arcing. *Photo 2* shows the spring-loaded contact points in detail and the non-metallic material between the copper alloy plates. The failure mode of the rotary style DC isolator is usually at this point of contact. If the spring-loaded contact force is not adequate, localised heating can occur. Heating at this point can further reduce the contact force, which makes the situation worse.

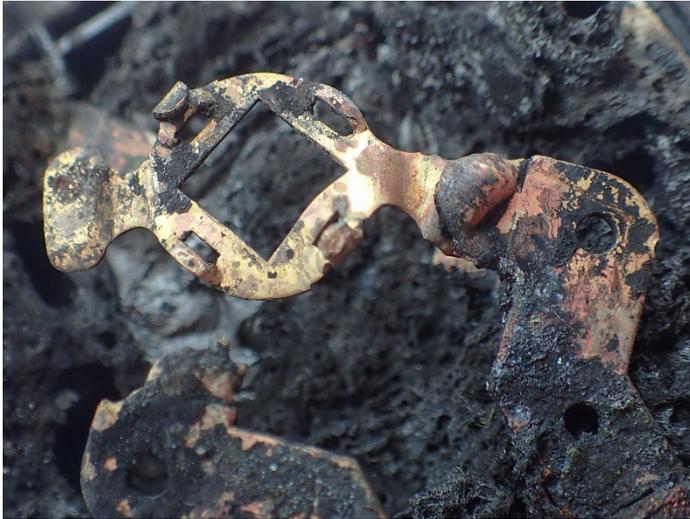
Photo 3: Welded contact points within a failed DC isolator

The failure mode of the rotary style DC isolator, is the result of higher than desirable contact resistance occurring on the contact interface between the spring-loaded contact points and the ‘knife edge’ terminal blade. The high contact resistance leads to localised heating at these points (*Photo 3*). As the metal parts within the isolator heat up they expand and distort very slightly. The spacer material may also soften and distort. This situation can lead to thermal runaway.

As the contact points of the isolator expand / distort the contact resistance increases. This results in further localised heating, which in turn leads to a further increase in contact resistance. This process continues until the temperature is high enough to ignite surrounding combustible materials such as the plastic exterior case.

The example of the failed DC isolator shown in *Photo 3* shows the molten copper and welded contact as a result from electrical arcing and extreme temperature ($> 1085^{\circ}\text{C}$, the melting point of copper). The unpiloted ignition temperature of plastic is in the range of $400^{\circ}\text{C} - 550^{\circ}\text{C}$. To further exacerbate this failure, the solar panels circuits remain energised, assisting in the spread of fire. There is no protection element on the output of the DC solar panel array that can detect a fault inside the DC isolator and so the fault condition persists until a complete failure occurs. Other investigations have found that the material selection (including the copper alloy contact material and the non-metallic material between these contacts) is not suitable for use in solar applications.

The designer of the rotary style DC isolator, or for that matter any electrical switch, needs to consider the effects of temperature on the spring-loaded contact points. The design could incorporate a rib on the contact arms, designed to increase the clamping force onto the ‘knife edge’ terminal blade as the temperature increases. This could be modelled using Finite Element Analysis (FEA) to determine an acceptable design. Insulator selection also needs to be carefully considered.
